Mr.K.N.Srivastava  
Secretary, Ministry of Civil Aviation  
Chairman, Civil Aviation Safety Advisory Council  
New Delhi

5<sup>th</sup> August 2013

Sub: DGCA Clearance for Operations on Secondary runway at Chennai

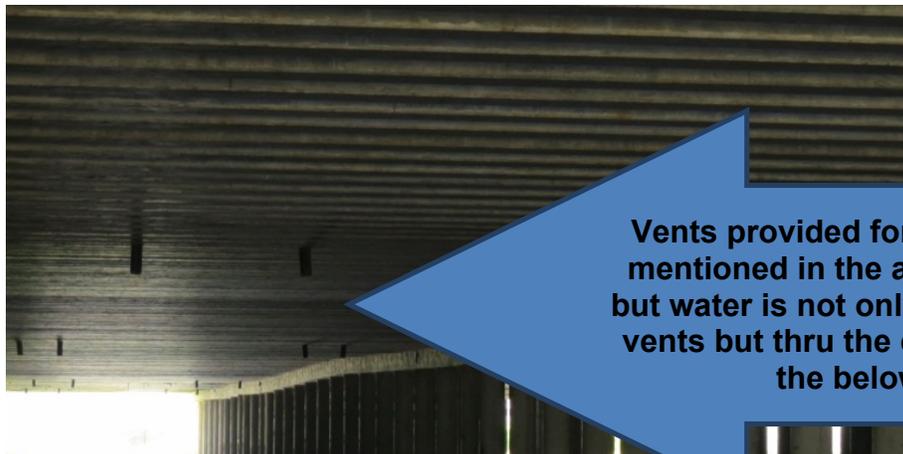
AAI , and its technical team state that sacrificial shuttering and drain holes for water are provided . This is well illustrated on the picture below .

**Vents provided for draining water as mentioned in the above explanation , but water is not only flowing thru these vents but thru the cracks as shown in the below picture**

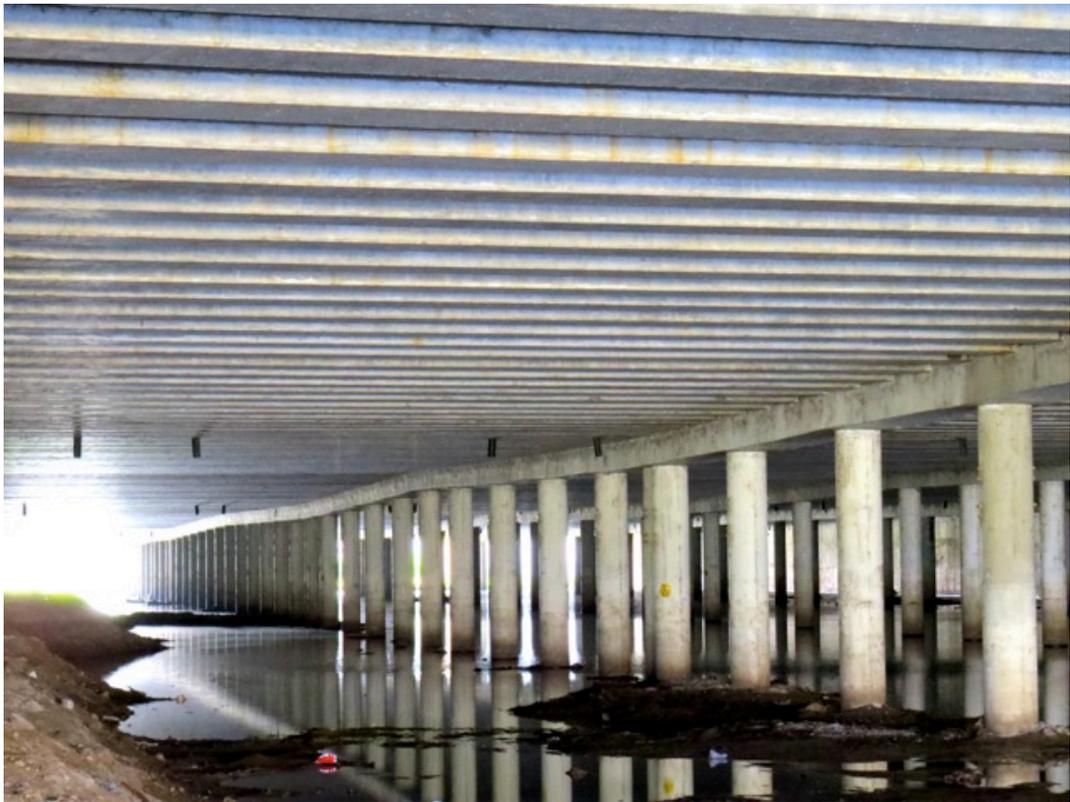
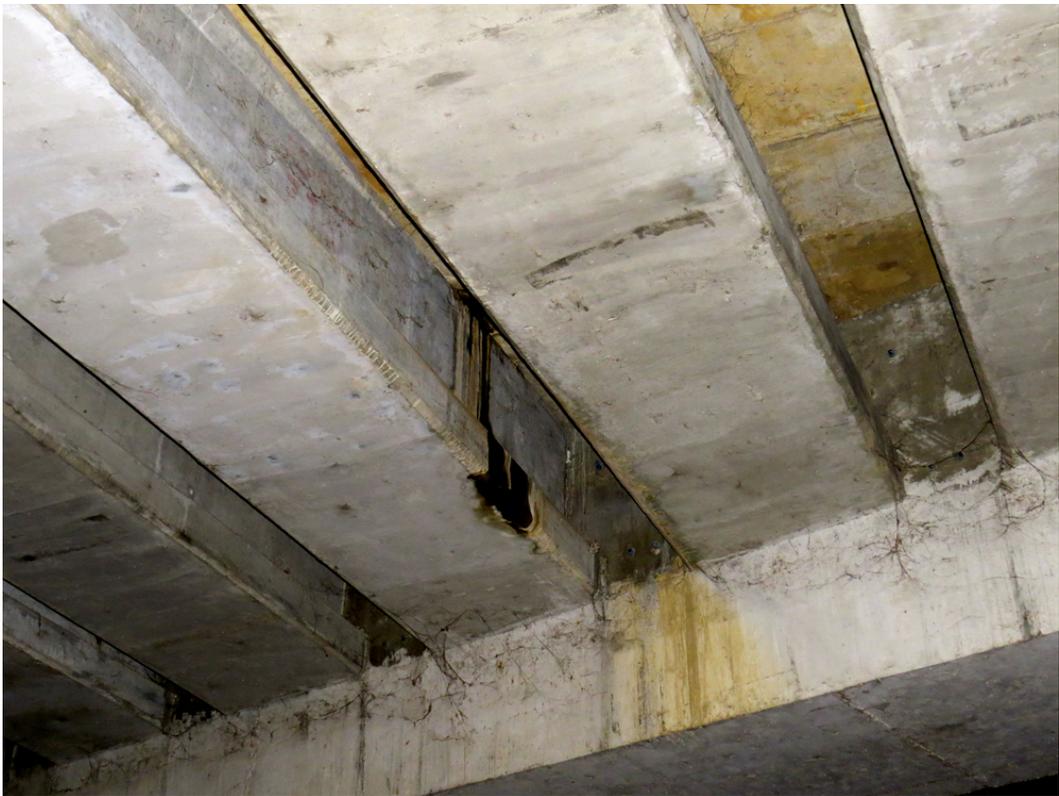
Contrast that with what is visible in the Secondary Runway bridge at Chennai that is LESS THAN TWO YEARS OLD:

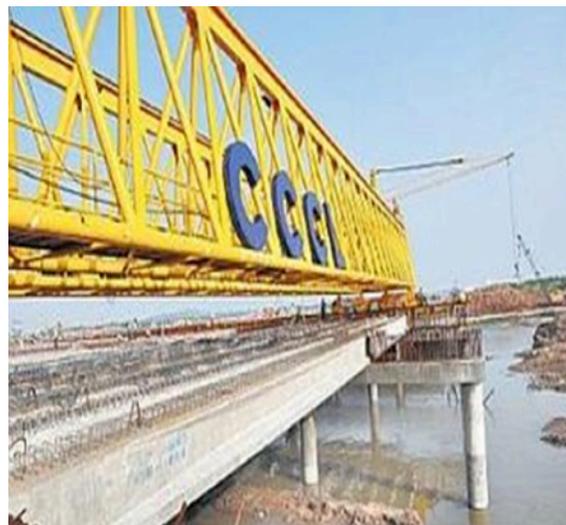
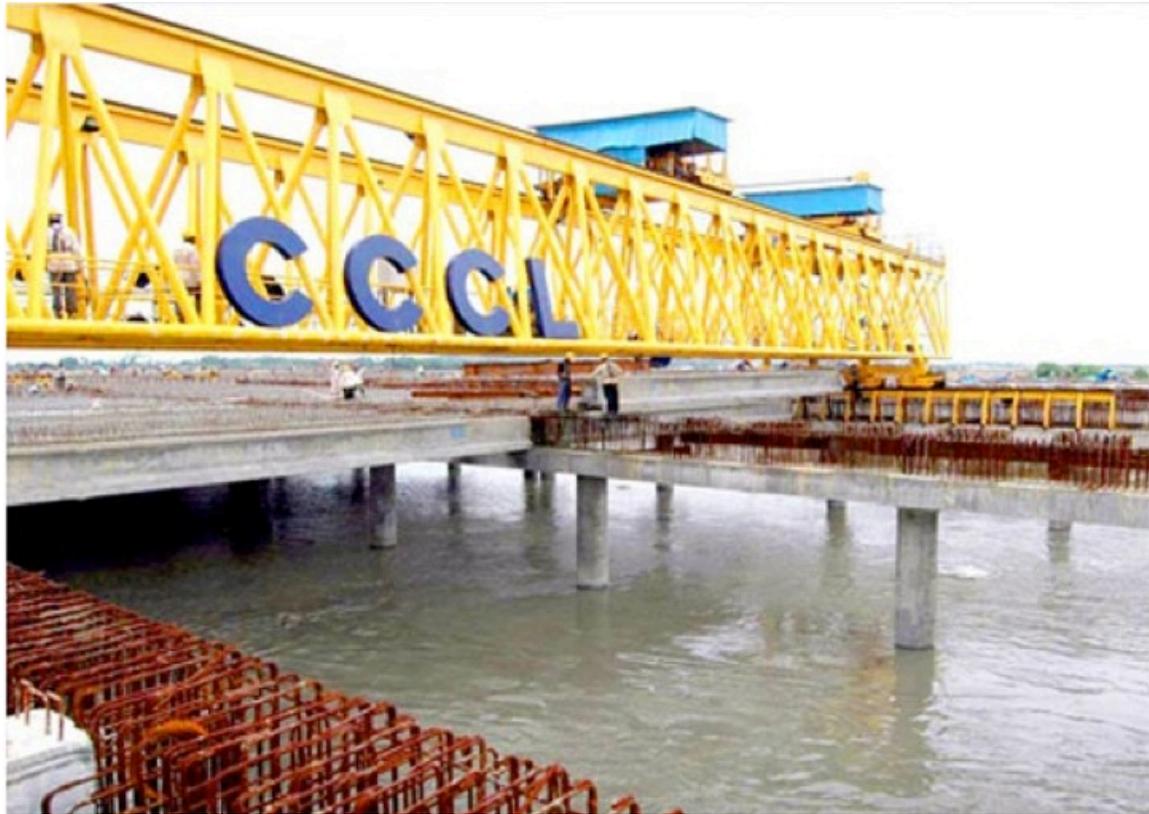
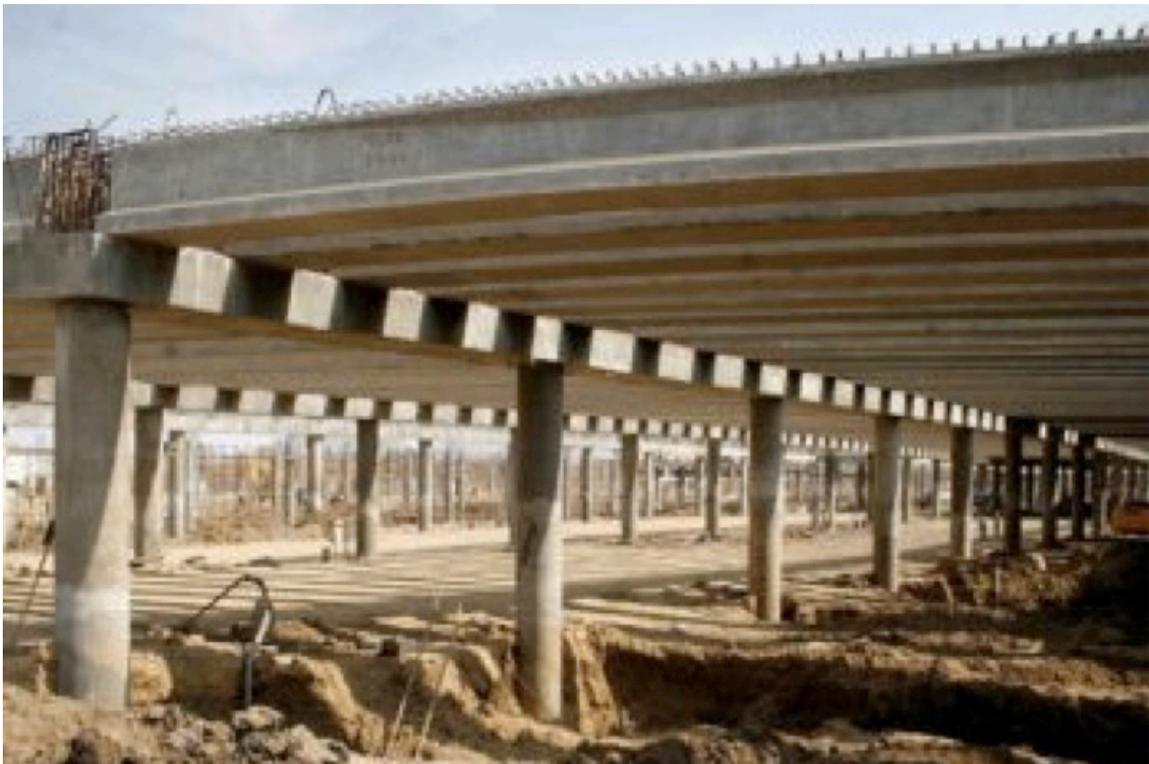
The construction was not carried out by L&T who have considerable experience in Bridge building but by a company CCCL, who have not even constructed a road bridge. Please note the images during construction and compare them with the Funchal airport bridge:
