Mr.K.N.Srivastava  
Secretary, Ministry of Civil Aviation  
Chairman, Civil Aviation Safety Advisory Council  
New Delhi

5<sup>th</sup> August 2013

Sub: DGCA Clearance for Operations on Secondary runway at Chennai

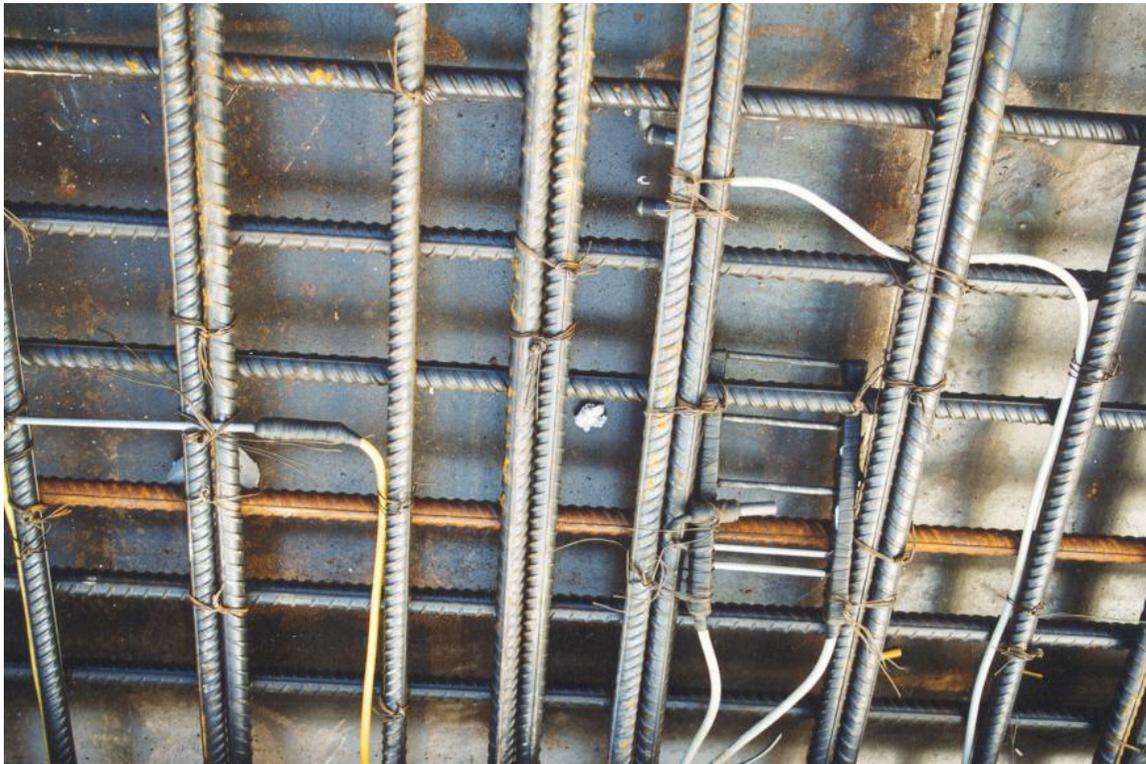
*Fig. 5. Sensors before concreting.*

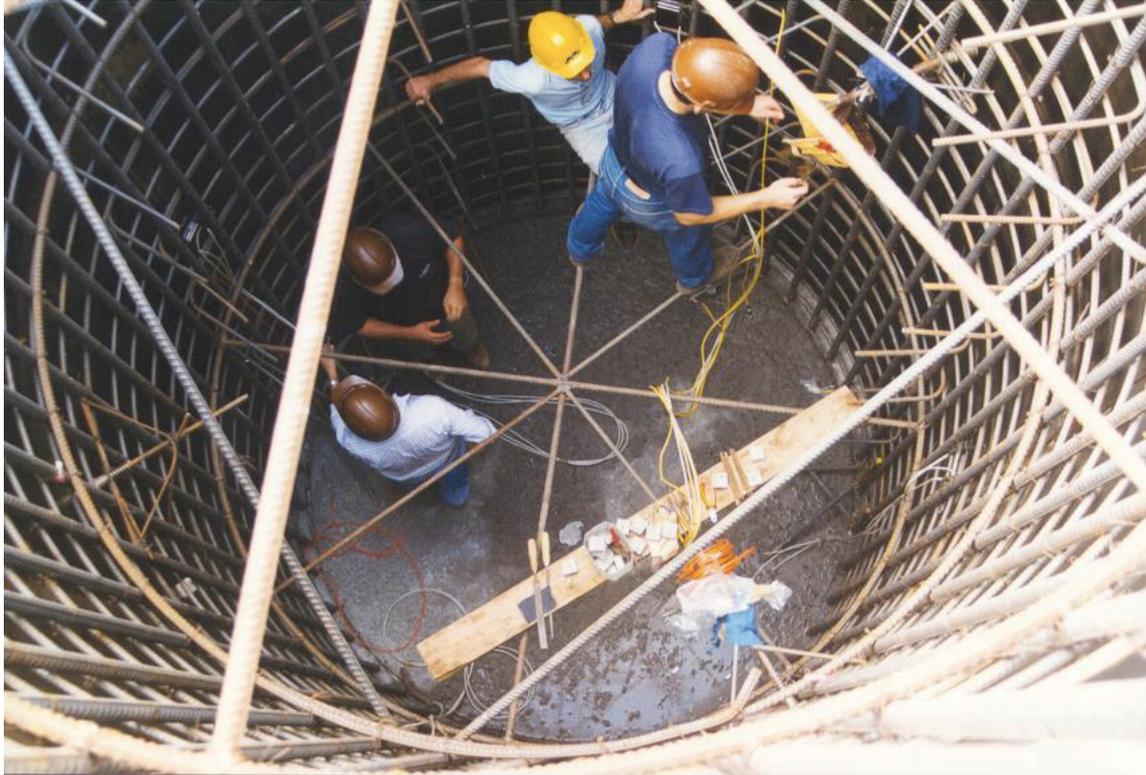
*Fig. 6. Instrumentation of pier.*

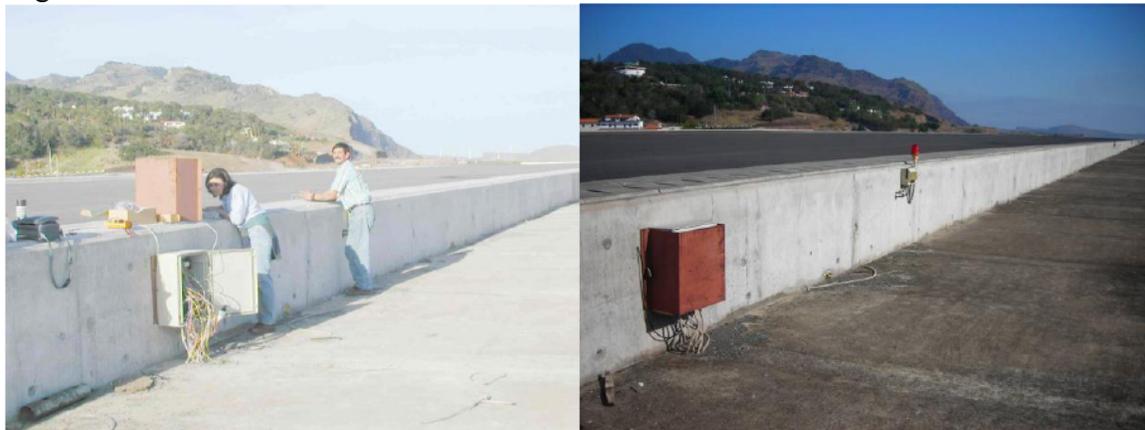
*Fig. 7. Centralization box installed next to the airport runway that receives all information from sensors installed in beams and deck slab. Top – during the installation of automatic acquisition of data. Below – ten years after.*

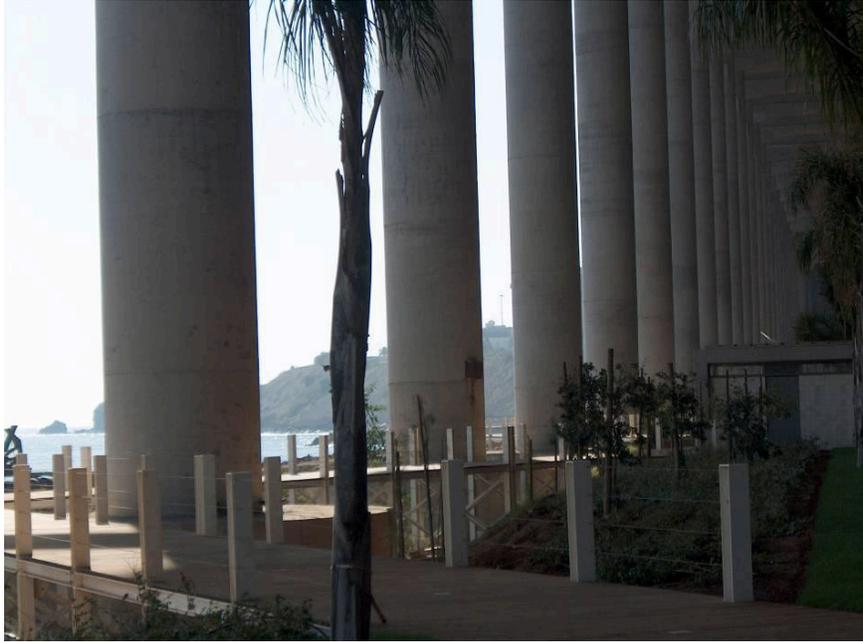
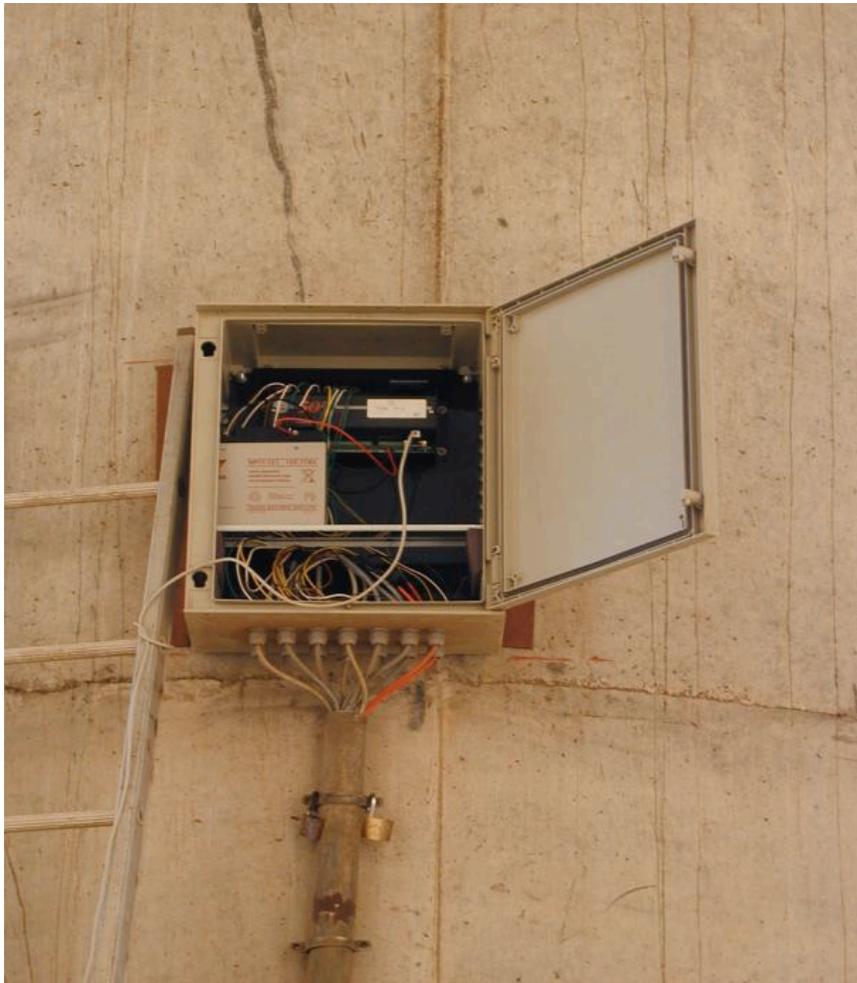
*Fig. 8. Current appearance of the centralization box installed on a pier.*

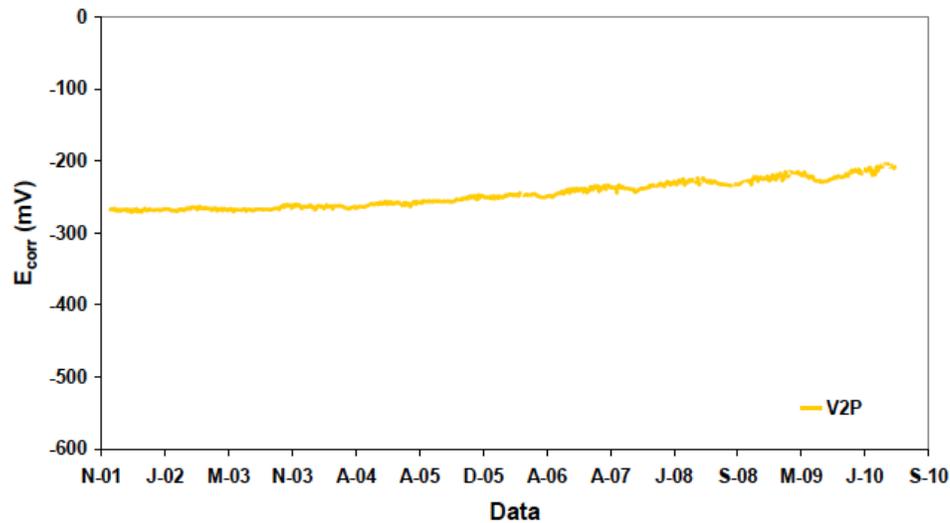
Corrosion potential ( $E_{corr}$ )

Measurement of  $E_{corr}$  showed that reinforcement corrosion do not start during the monitoring period.

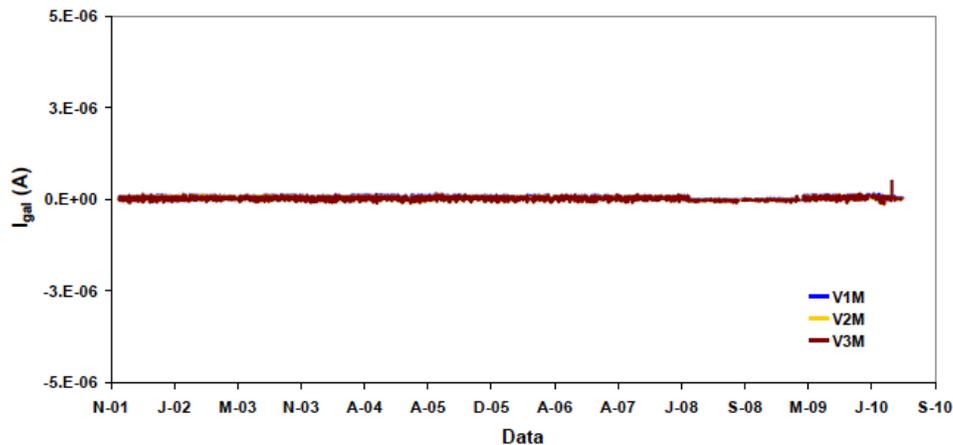
Galvanic Current ( $I_{gal}$ )

Galvanic currents measured during the monitoring period are low and indicative that the reinforcement is not corroding.

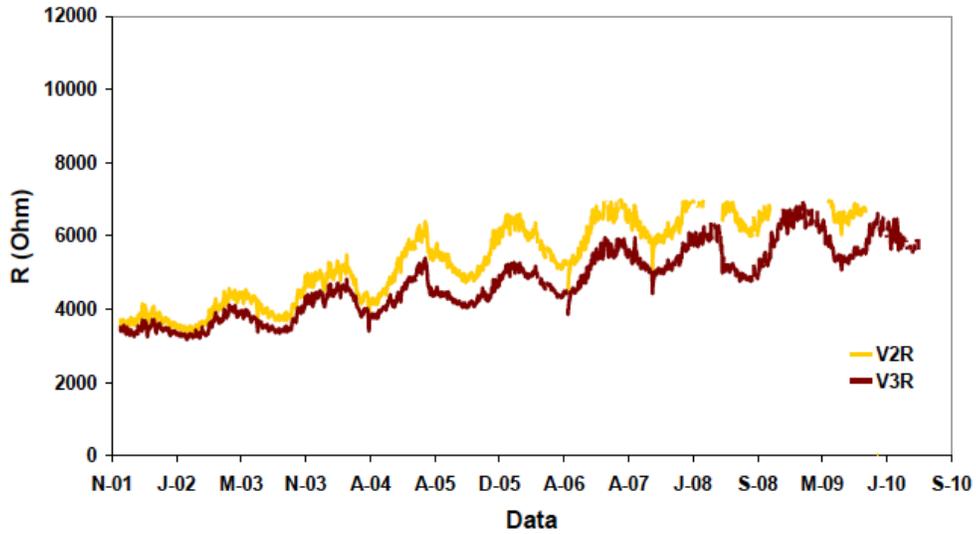
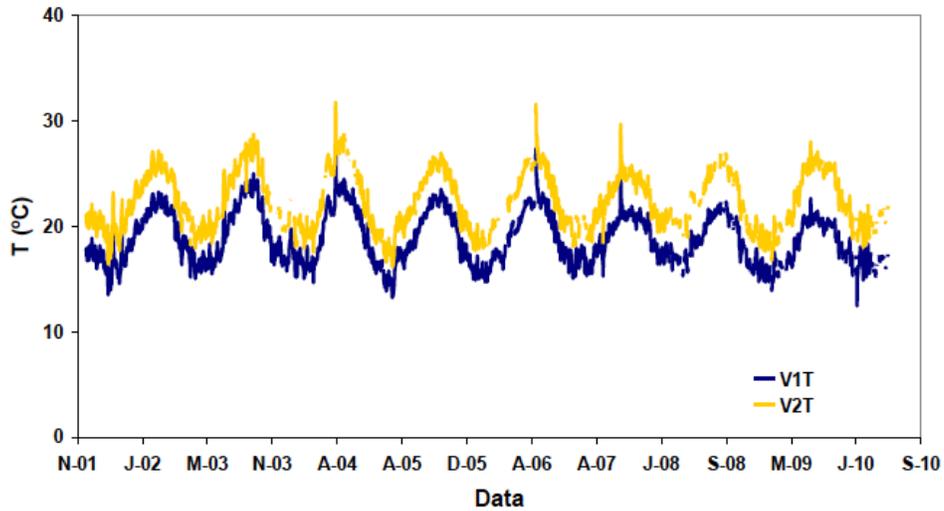
Concrete electrical resistance (R)

No significant changes of R occurred during the monitoring period. R variations have been attributed to the variations of environmental parameters and to the evolution of concrete hydration over time.

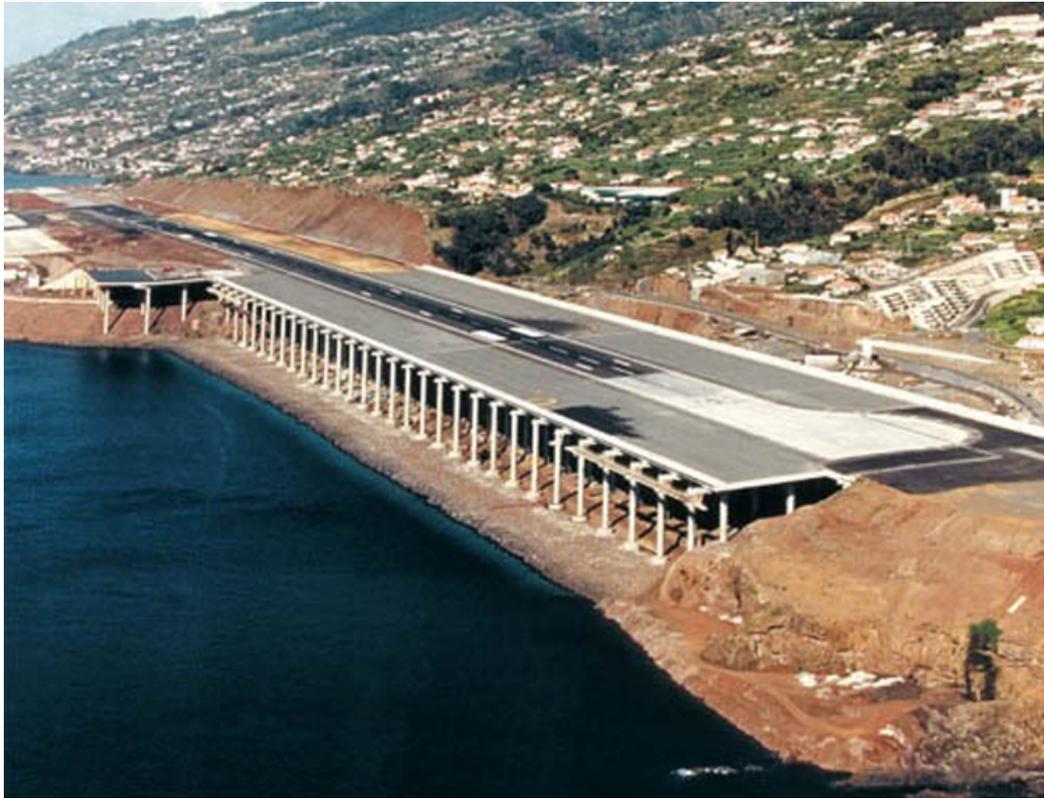
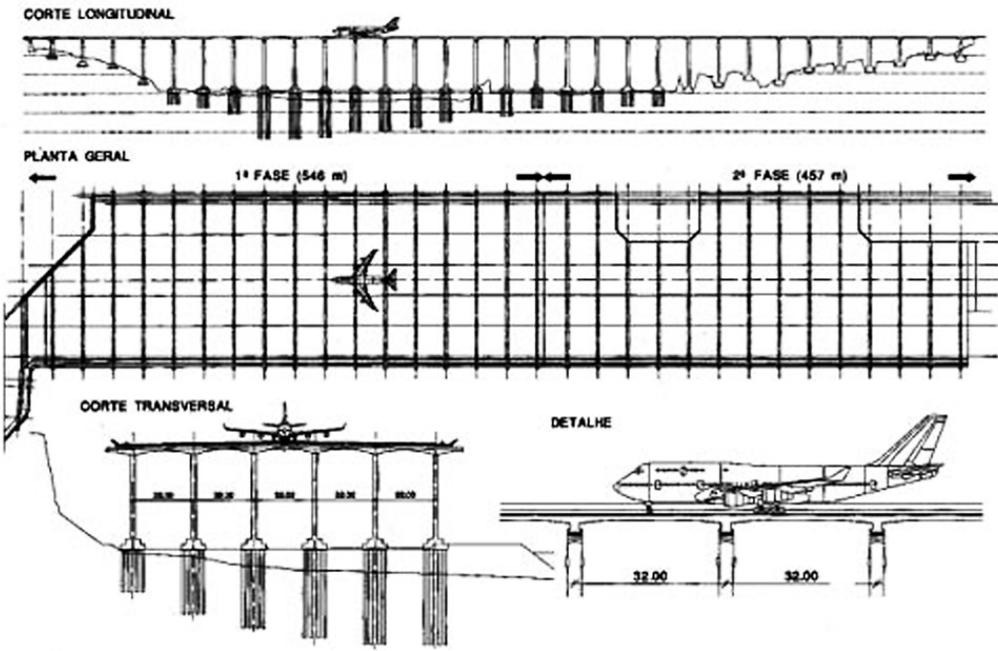
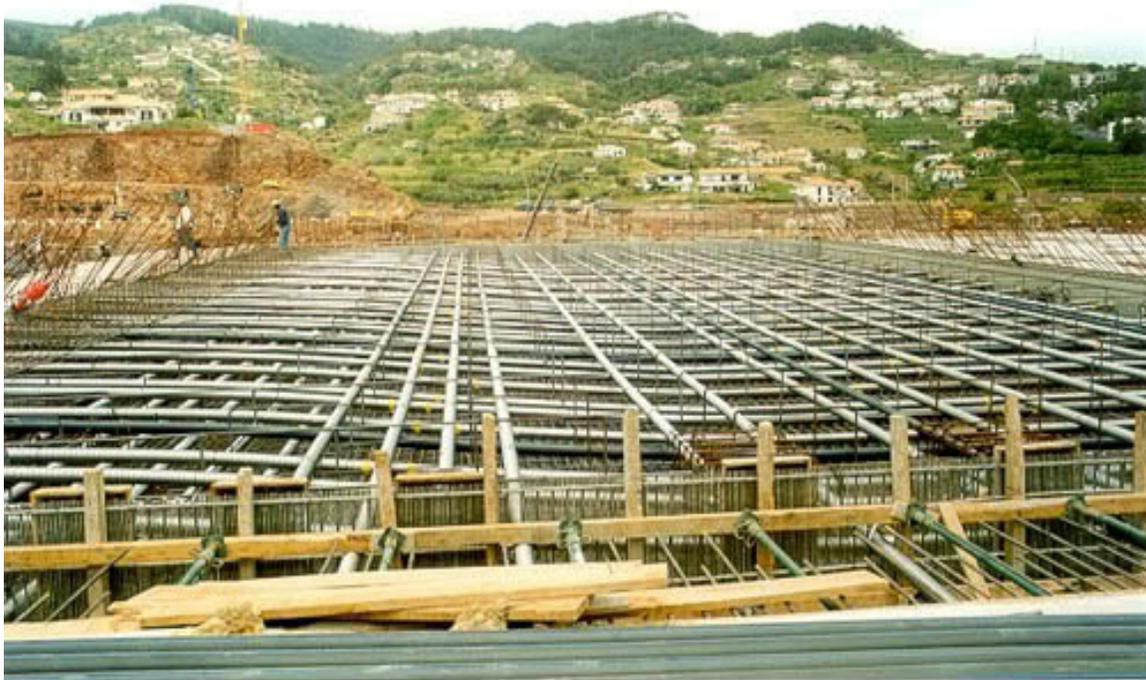
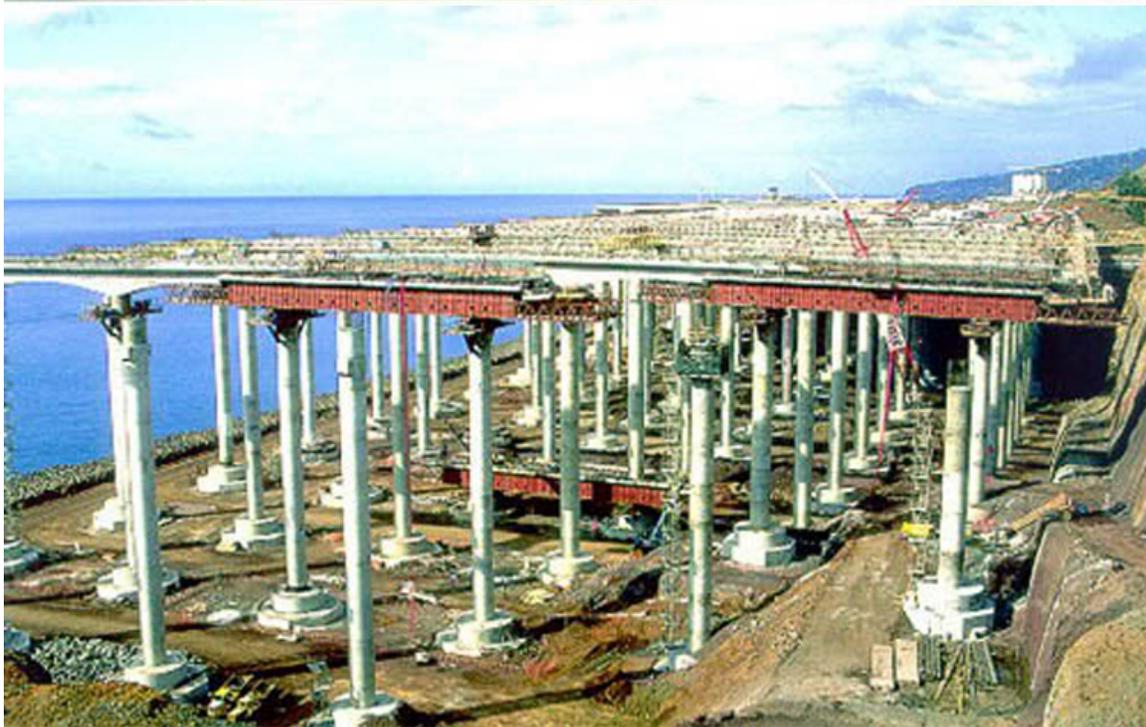
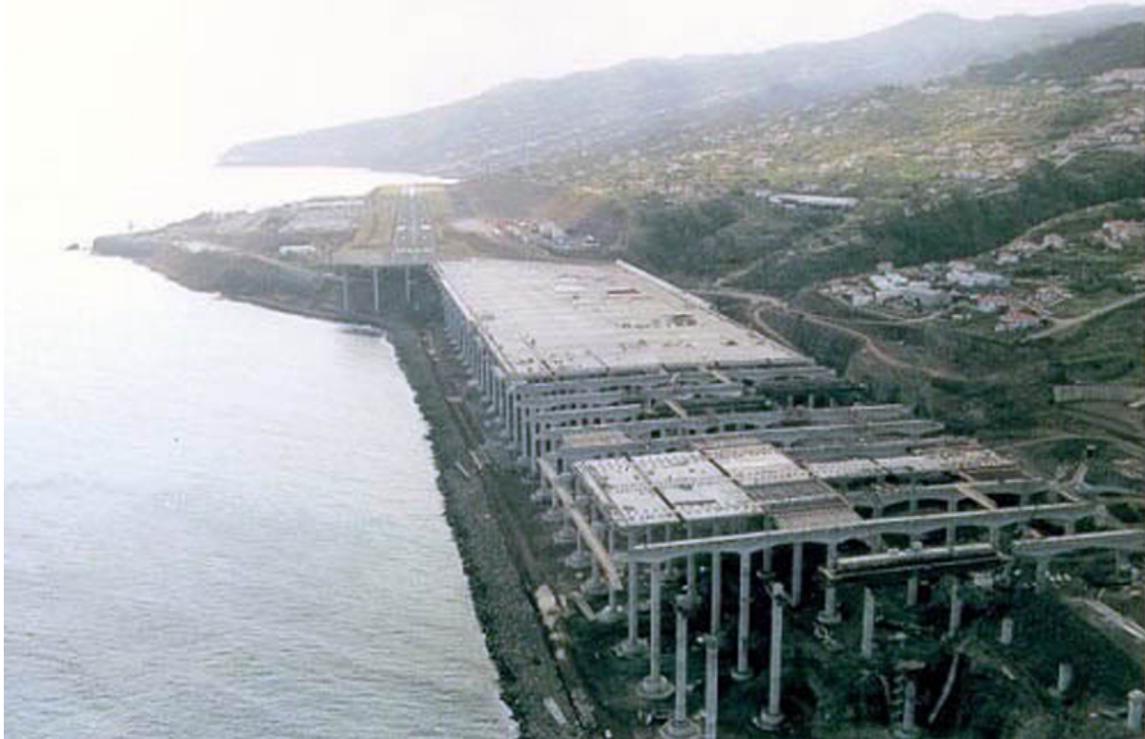
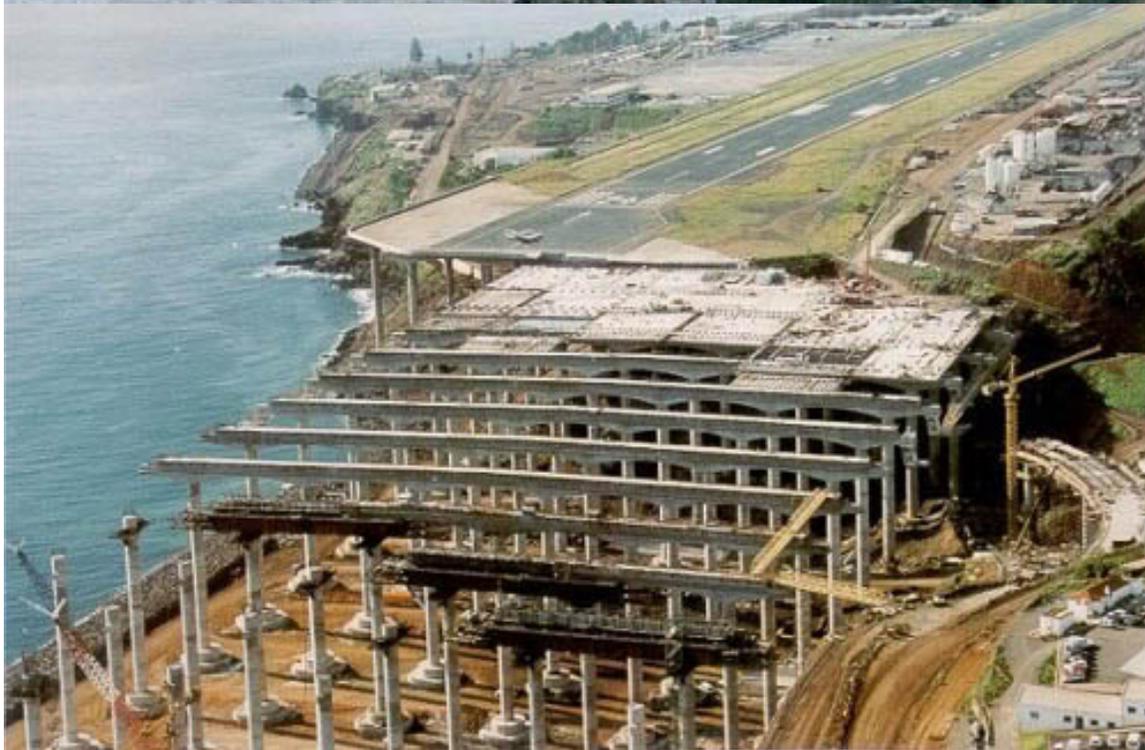
You will notice that the beams are absolutely LEVEL and it is only the supporting pillars (piers) that vary in length to cater for difference in the ground levels. The images taken during the construction will show that there are no variations in the levels of the beams.

Funchal runway is more than TWELVE years old. There is no corrosion on the structure and they have installed several sensors as listed above, in the technical report.
